Essay #6 of a series written by Alabama preservationists to supplement the *Handbook for Owners of Alabama's Historic Houses*, Alabama Historical Commission, 2001

CHIMNEYS

Robert S. Gamble

Historical Notes on Alabama Chimneys

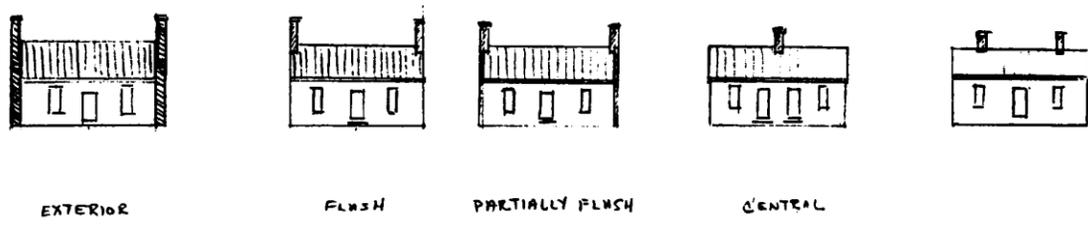
Figure 1 - Typical chimney placement in early American buildings.

The typical chimney in early and mid-19th century Alabama was placed at one or both ends of a structure. Usually the chimney was extruded from the main wall plane, although sometimes it was incorporated into the end wall itself as a flush chimney. A variant on the flush chimney arrangement was the partial extrusion of the chimney from the wall plane. (fig. 1) While flush chimneys normally occur in masonry structures, they are on rare occasions also found in frame buildings, one example being Tusculumbia's 1825 Pearsall house. This treatment is apparently a holdover from eighteenth century practice in Maryland, Virginia, and the Carolinas, and may denote a building of early vintage.

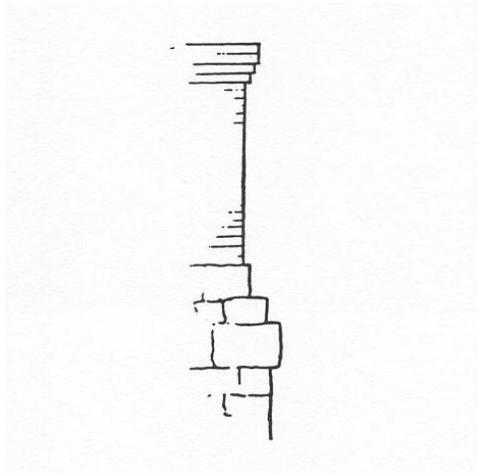
Figure 2 - Stone chimney with brick chimney stack.

In many clapboarded rural houses the chimneys were a combination of stone and brick - built of roughly chiseled random ashlar limestone up to the "shoulders" where the chimney narrows down to form the

flue that extends above the roof. (fig. 2) The top portion of the chimney was then completed with brick. At first this presents a strange and makeshift appearance, but it is practical in that the stone was readily available and cheaply prepared and the brick was not. The brick was apparently used for the upper flue because it was easier to lift to the 20-30 foot height and easier to work with in building the narrow upper flue.

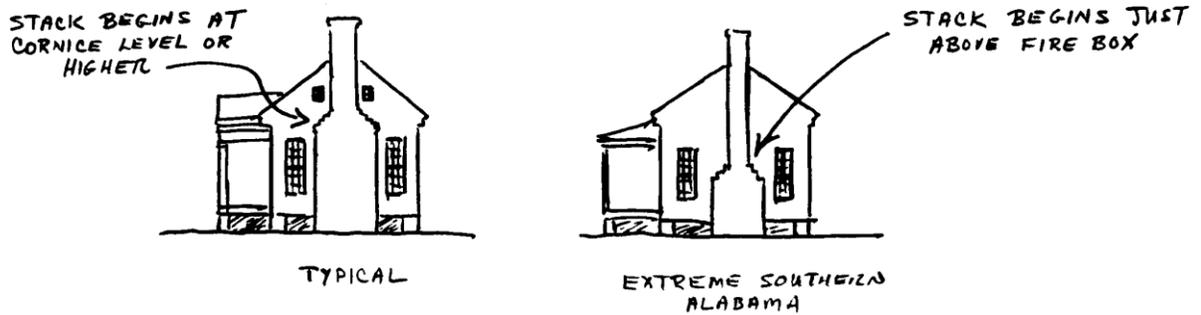
Figure 3 - Typical Alabama chimney profile, ca. 1810-1880.

A fundamental characteristic of the earliest chimneys in Alabama is apt to be their generous size, surprising perhaps in a deep southern climate. A typical chimney built before 1860 may range from six to seven feet or more in width at the base, and over two feet in thickness. Kitchen chimneys may be even larger. One may also observe subtle regional variations in form and size. For instance, chimneys in the extreme southern part of the state tend to be not only smaller in their overall dimensions, but also distinguished by a foreshortened base which breaks into the stack just above the firebox. (fig. 3) Upper chambers were often left unheated through South Alabama's short, mild winters.

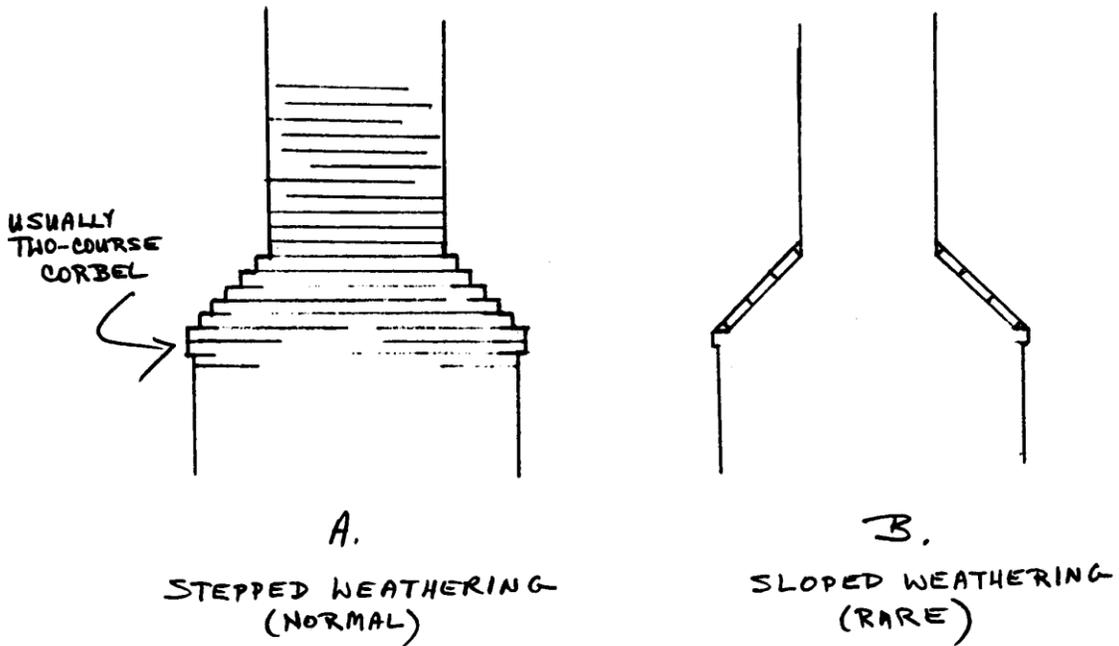
Figure 5 - Weatherings on early Alabama chimneys.

Almost universal in 19th century Alabama chimney construction is the use of stepped - as opposed to sloped - weatherings (the weatherings of a chimney being the inward-breaking haunches above the chimney base, where the base joins the narrower stack). The stepped configuration of the weatherings is normally emphasized by a corbel at the base of each weathering, this corbel almost invariably being composed of two courses of laterally projecting brick. (fig. 5A) From each corbel, the bricks of each weathering are then stepped progressively inward to the chimney stack itself.

Very rare and usually very early - in fact, another 18th century holdover - are chimneys with sloped weatherings. Here, the weatherings are composed of bricks laid end-wise in a diagonal from the chimney base to the stack. (fig. 5B) In either case - whether the weathering is stepped or sloped - the chimney stack usually rises to a cap which likewise consists of two or three courses of brick, corbelled outward. (fig. 6) Sometimes, though not often, cut stone may be used for the chimney cap itself.

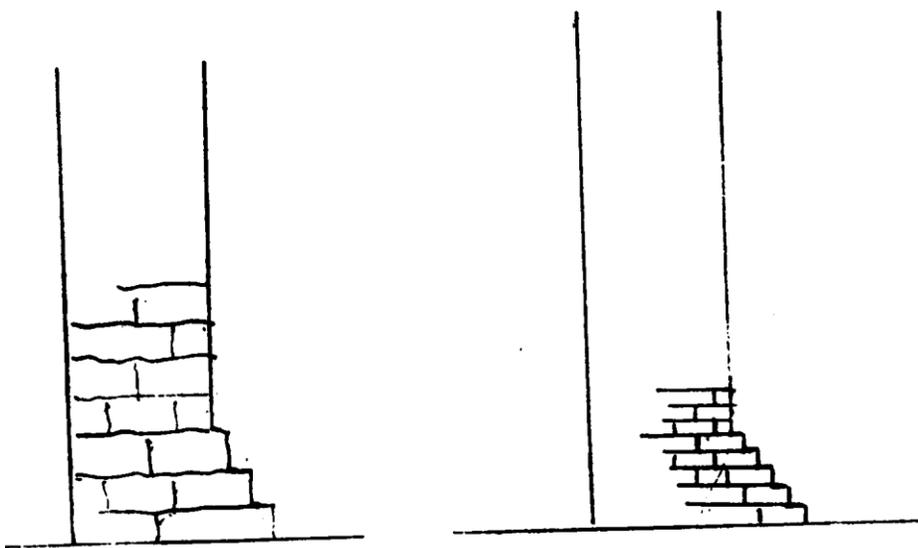
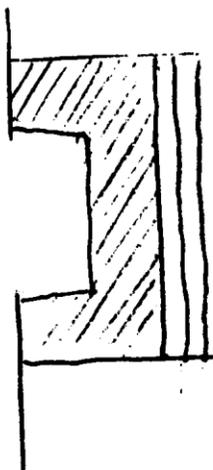
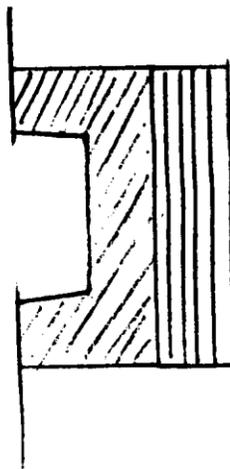
Figure 7 - Side elevation (upper drawings) and base plan (lower drawings) for stone and brick corbelled chimney foundations.

Another characteristic feature of early and mid-19th century Alabama chimneys is the massive, corbelled foundation which earmarks many of them. (fig. 7) This foundation may consist either of brick or rough-hewn stone. In cases where brick is employed, the corbelling may extend as much as ten courses outward from the main vertical plane of the chimney base. The rationale for such massive foundation work is obvious where the primary building material is wood - the chimney then having to carry its own weight entirely and be braced so as not to lean outward.

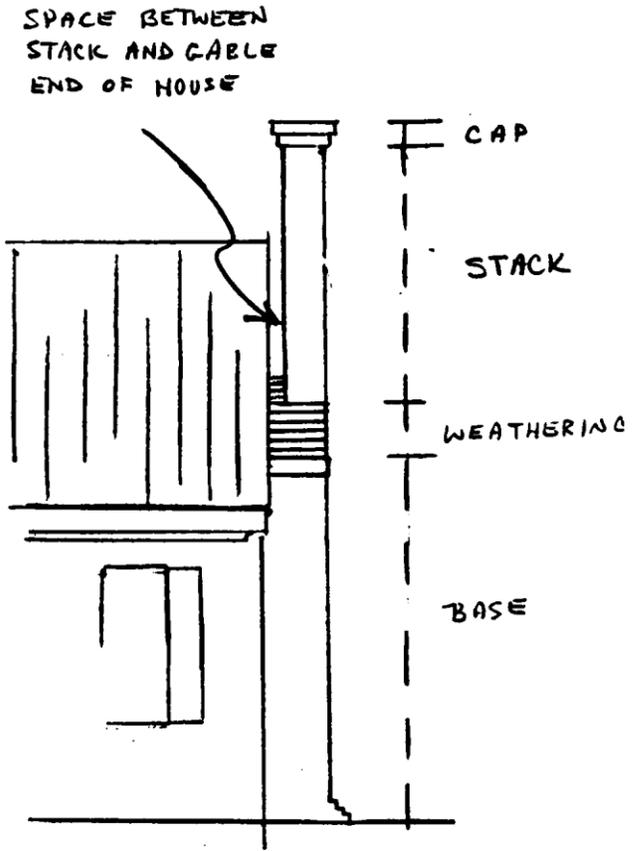
Figure 8 - Profile of typical early to mid-19th century construction showing break-away stack.

Still another common feature to be observed in chimneys dating from the early and mid-19th century is the breaking of the chimney stack away from the main wall of the house above the weatherings. (fig. 8) This was for fire protection, since the brick flues were unlined and could develop holes where mortar joints deteriorated. A hole in the flue could allow sparks to escape from the chimney stack into the attic. A freestanding stack lessened the chances of this occurring and resulted in an attractive appearance as well. Sometimes the stack may break as much as six or eight inches from the main wall or gable end of the structure it serves, though normally the space is only about four inches wide.

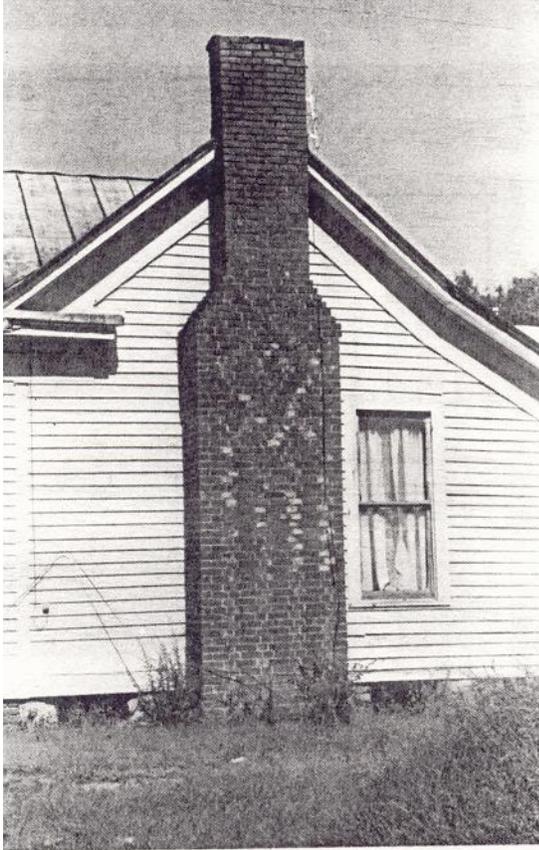
Figure 9 - Diaperwork chimney, Madison County. Note diamond pattern just beneath stepped weatherings. The chimney stack appears to have been rebuilt at a later date - perhaps when the house itself was enlarged and remodeled. Only three examples of early nineteenth century diaperwork chimneys have to date been documented in Alabama.

While most chimneys in early Alabama were devoid of ornamentation, there are a few extremely rare examples of what is known as “diapering” or “diaperwork.” (fig. 9) Originating in the Middle Ages and quite widespread in colonial America, this is the practice of placing glazed brick headers in a diamond or lozenge pattern on the face of the chimney as a sort of rudimentary embellishment. Perhaps the finest example of diaperwork chimneys in Alabama were those of the Jacob Green house in St. Clair County - destroyed in 1982. Diaperwork chimneys also occur at the Sellers-Henderson house in Wilcox County.

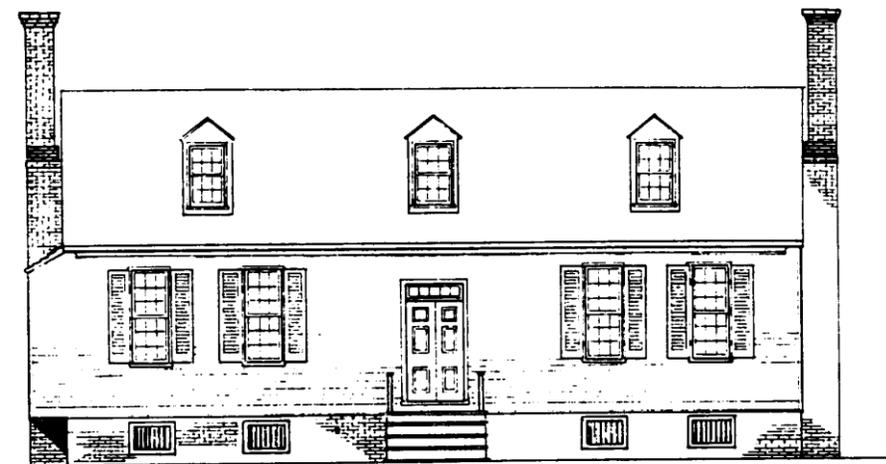
Figure 10 - Chimney pent at Bride's Hill (ca. 1830), Lawrence County. A similar pent abuts the right chimney on the rear side of the house. Note that the pent is cantilevered out from the main foundation.

Almost equally as rare in Alabama is the chimney accessory known as the “chimney pent.” (fig. 10) Often times found on 18th century houses of Tidewater Maryland, Virginia, and the Carolinas, the “pent” is the small shed-roofed closet space abutting one side of the chimney. Only a handful of Alabama examples have been documented, although others probably once existed. Typically, the chimney pent flanks one or both sides of the chimney and may be cantilevered from the main foundation of the house.
