Middle Bay Lighthouse, Mobile Bay

Condition and Action Plan

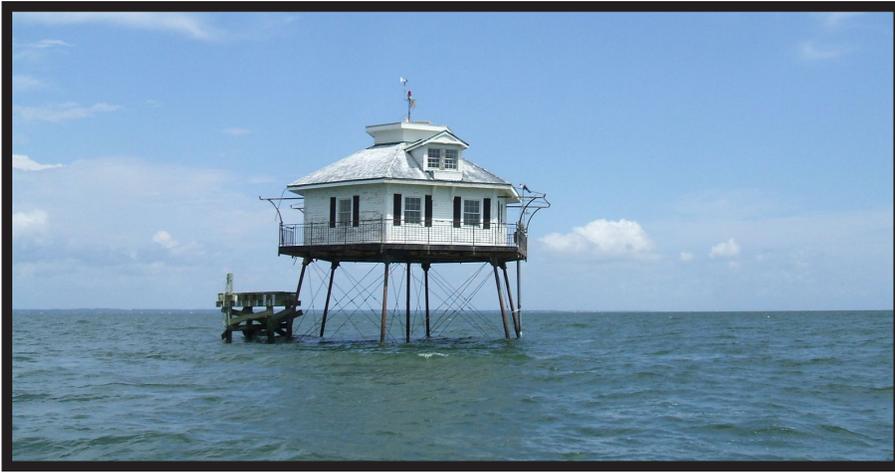
Constructed in 1885, the Middle Bay Lighthouse is a screw-pile lighthouse. Due to high labor costs in the South, the lighthouse was constructed in the North and shipped to the bay. Seven wrought iron legs (piles) screwed into the bottom of the bay support the hexagonal wood-framed structure. The lighthouse is still used today as a navigation aid with a battery-powered beacon maintained by the Coast Guard.
